CAPE ROYAL ROAD  
(Grand Canyon Route #3)  
(Point Imperial-Cape Royal Road)  
Between North Entrance Road and Cape Royal  
Grand Canyon National Park  
Coconino County  
Arizona

HAER No. A7-40

HISTORIC AMERICAN ENGINEERING RECORD

INDEX TO PHOTOGRAPHS

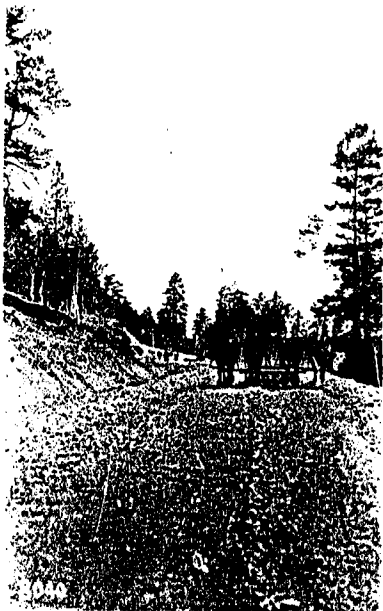
Figure 2. Teams finishing the roadway at Station 32+00 along Bright Angel Point, ca. 1929. (construction reports GCSC)

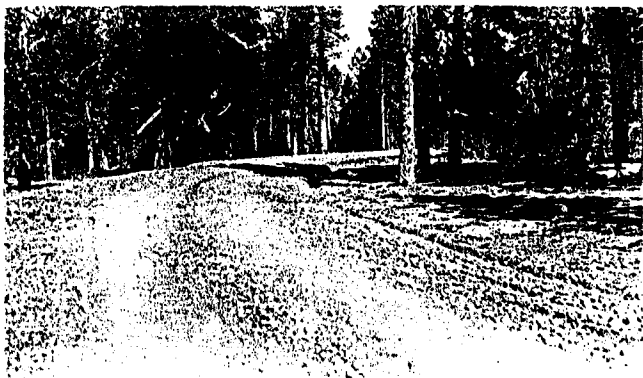
Figure 3. Completed roadway at Station 518+00, ca. 1929. (construction reports, GCSC)

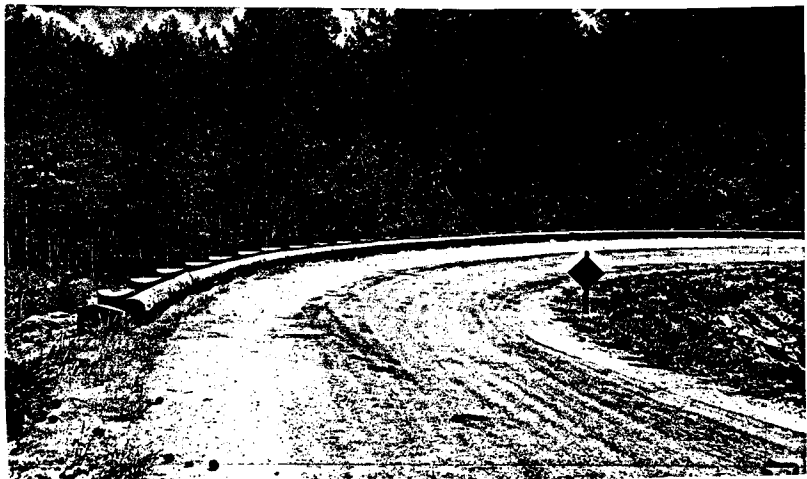
Figure 7. Park forces guardrail project along Cape Royal Road, 15 July 1937. (GRCA Image #4002, GCSC)
